SUBJECT: Historic Designation of England/Crown Farm Buildings

England-Crown Farm Building Assessment

9800 Fields Road
Gaithersburg, MD

CITY OF GAITHERSBURG – CROWN FARM BUILDING ASSESSMENT

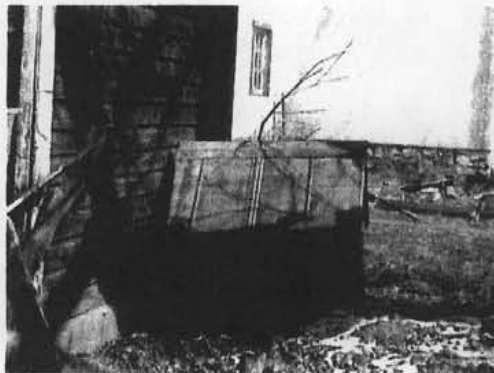
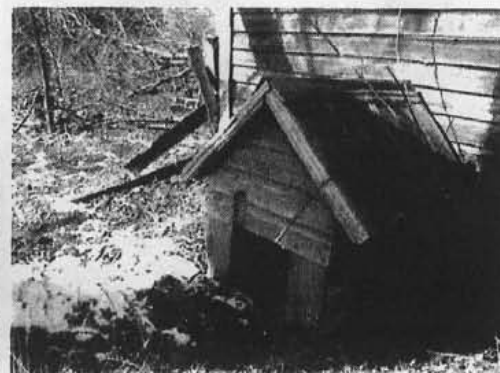
Figure 4

The building is in fair to poor condition and is in a state of neglect. Paint is peeling and there are areas of bare wood and improperly fastened wood siding. The tin roof has areas of rust.

There is no historic, cultural or architectural significance to this structure. This structure dates from the third period of construction ownership (See Sketch)

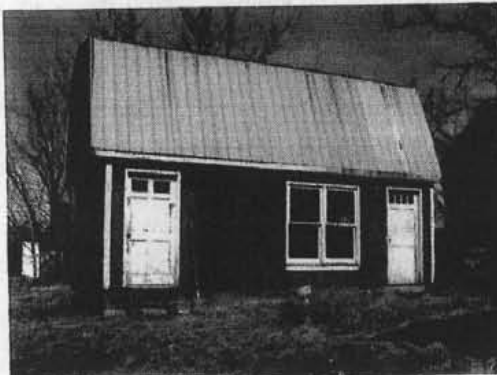
Figure 6

Building D, is a two story wood framed structure sheathed with four by eight sections of painted plywood, with vertical wood corner posts, painted. It has a tin gambrel roof. The structure, rectangular in plan, about sixteen feet wide by twenty-four feet deep, sits atop a concrete foundation, painted. There are two doors and a paired double hung window on the

The building is in fair condition. It looks as if it were recently remodeled as the doors, several of the windows and steps are of recent construction materials. There is paint adhesion failure on all facades and there are patches of bare wood. There is evidence of moisture damage to areas of the wood exterior sheathing, at the corner posts, and at the roof cornice board. There is evidence of moss and biological growth at concrete foundation at the north side, indicative of moisture infiltration. The gambrel roof has rust streaks on both the north and south exposures.

There is no historic, cultural or architectural significance to this structure. This structure dates from the third period of construction ownership (See Sketch).

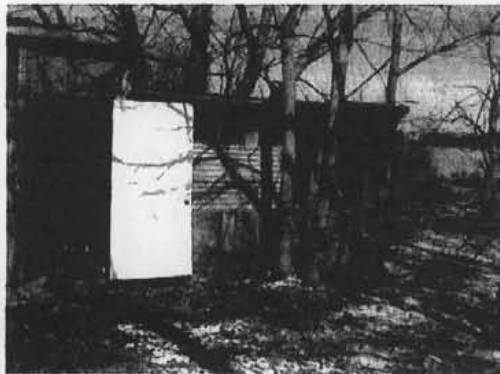
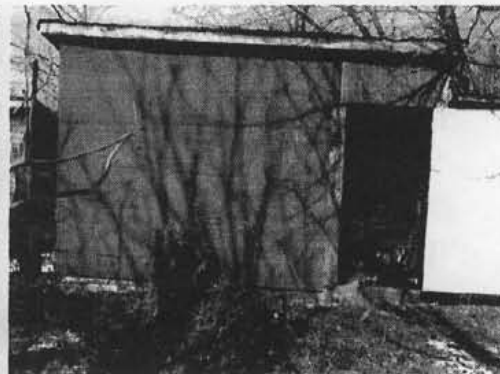
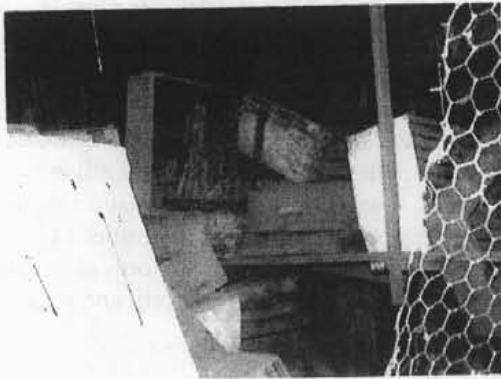
Figure 9

The buildings are in fair to poor condition and in a state of neglect. There is evidence of moisture damage at the exterior and the interior surfaces. The roof and wood roof framing structure are in fair condition but there are some moisture infiltration issues. The doors do not operate well and they lack proper hardware.

There is no historic, cultural or architectural significance to these structures. They date from the third period of construction ownership (See Sketch).

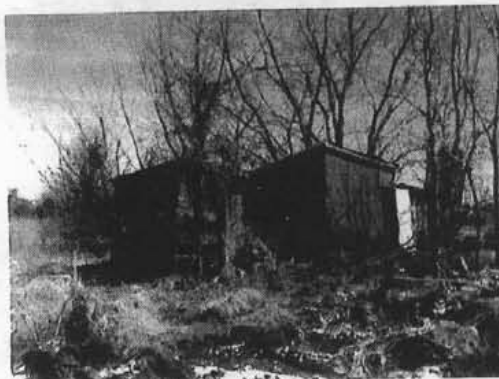
Figure 13

This building is in poor condition, in a state of neglect and disrepair. The framing of the shed is racking and leaning and the fasteners at horizontal planks are failing which has caused the siding to separate and has allowed weather penetration. There is moisture damage at the roof system. The door framing is racked and the door does not operate and lacks proper hardware.

There is no historic, cultural or architectural significance to this structure, however the existing wood materials that are in usable condition should be salvaged. This structure dates from the third period of construction ownership (See Sketch).

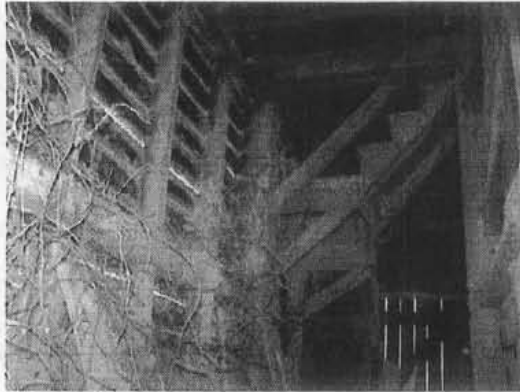
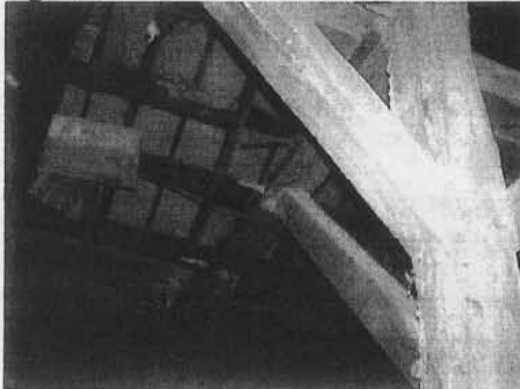
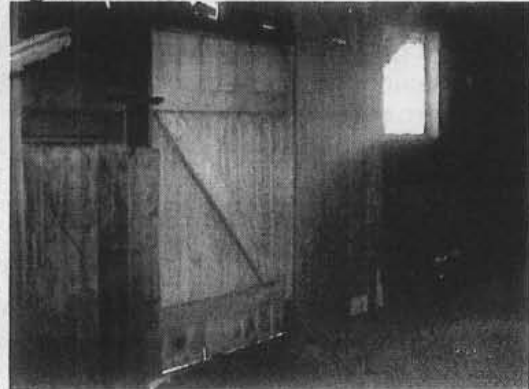
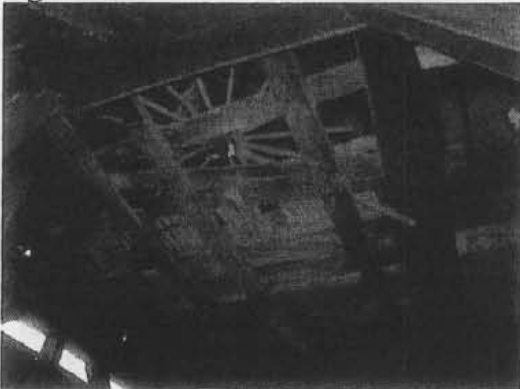
Figure 43

Building N is in fair condition. At the exterior, paint is peeling and there are areas of bare wood. There is evidence of moisture damage to the wood exterior sheathing especially near the concrete foundation. There is some damage to the structural members at the second floor framing requiring repair. The stairs leading to the second level need to be reinforced as well. The exterior wood sheathing is in poor condition as there is noticeable deterioration and moisture damage. Some of the sheathing is loose due to failure of the fasteners. The roof has corrosion on the exterior face however, the interior surfaces do not show signs of corrosion.

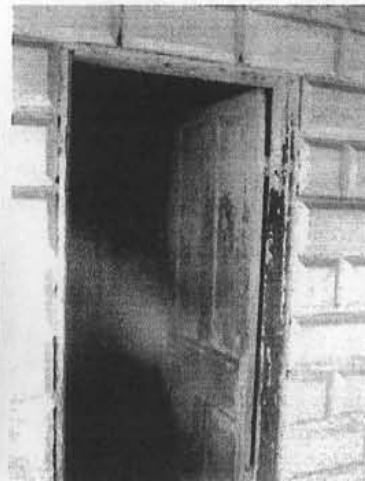
Figure 77

Building R-2

From a historic, cultural and architectural point of view, this building should be considered highly significant and worthy of preservation. It is an example of an early 20th century milk house, a structure that served an essential function in the evolution of this site into a modern dairy farm. The introduction of modern technology and modern materials are still represented at this structure. A network of piping brought milk from the dairy barn into the Milk House where the milk pasteurization most likely occurred. The use of concrete block noted at the walls is also significant as the use of this product became very popular in dairy building design. Concrete block was the preferred material at the time since it provided for smooth, clean interior walls.

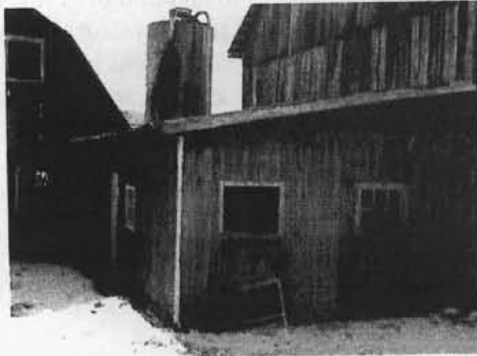
Figure 78

Building R (Adjacent Shed Structures)

There is no historic, cultural or architectural significance to the structures; however the existing wood materials that are in usable condition should be salvaged. This structure dates from the third period of construction ownership (See Sketch).

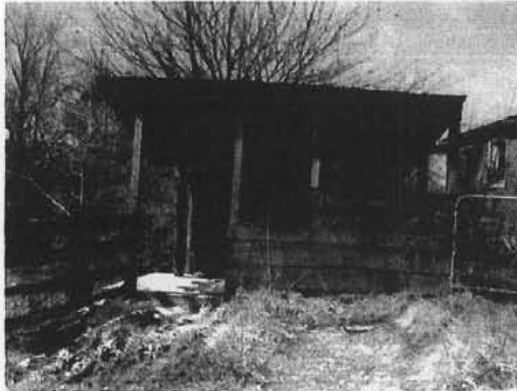
Figure 80

Building S (Feed Chute/Cow Holding Structure)

There is no historic, cultural or architectural significance to the structures; however the existing wood materials that are in usable condition should be salvaged. This structure dates from the third period of construction ownership (See Sketch).
